Strength Degradation of Filament-Wound Graphite/Epoxy Tubes Due to Either Impact Damage or Fabrication Defects

1 August 2004

D. J. CHANG and H. A. KATZMAN
Space Materials Laboratory
Laboratory Operations

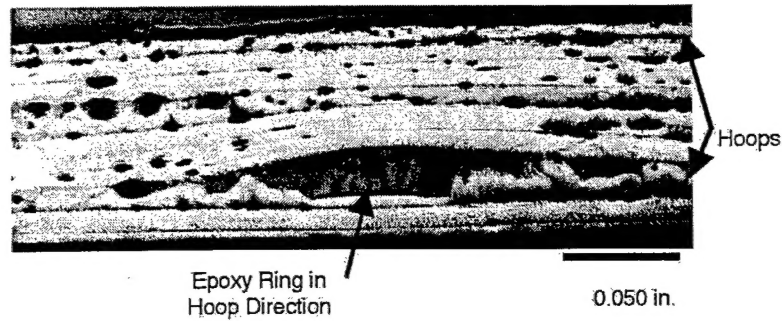
Figure 2. Cross section of minor helical-wrinkled tube (view of axial-radial plane).

The average burst pressure for the wrinkled tubes was 20.8 MPa (3022 psi). The helical wrinkle did not noticeably degrade the tube strength. One reason is that the strength of the tube is dominated by the hoop fibers. The composite stress in the hoop direction is twice the stress in the axial direction. However, the number of helical fibers is twice that of the hoop fibers. This results in an approximate

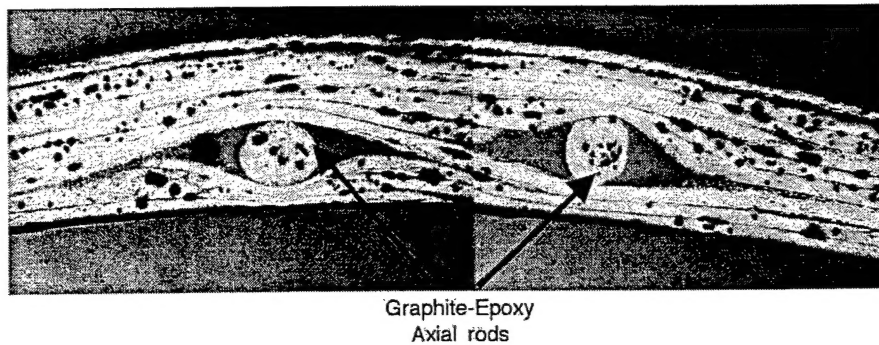
Figure 3. Cross section of hoop-wrinkled tube (view of radial-circumferential plane).

Hoop wrinkles significantly reduce the burst pressure. The fabricated hoop wrinkle was much more effective in degrading the strength than the helical wrinkle. The burst pressures range from 15.1 to 18.7 MPa (2195 to 2716 psi). The strength reduction averaged 14% and was as much as 23% of the pressure for un-wrinkled specimens. Figure 10 depicts a failure as well as the subtracted frames from the respective reference frame at 74- μ s time intervals. The fractures are all longitudinal.

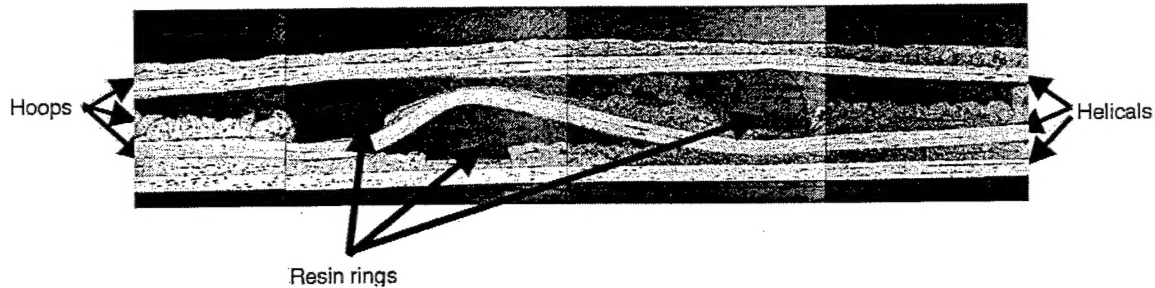
Figure 4. Cross section of severe helical-wrinkled tube (view of axial-radial plane).

A total of three wrinkled and two non-wrinkled specimen from this $(+15^\circ, -15^\circ, 90^\circ, 90^\circ)_3$ tube were tested. The average burst pressure of non-wrinkled specimens was 52.82 MPa (7658 psi), and the average burst pressure for wrinkled tubes was 48.82 MPa (7078 psi). This gives a 7.6% average strength reduction. The failure mode of the specimens in this test series is different from those in the previous three groups in which the failures were dominated by the hoop fibers with little influence from the helical fibers. This was true because there were half as many fibers in the hoop direction as

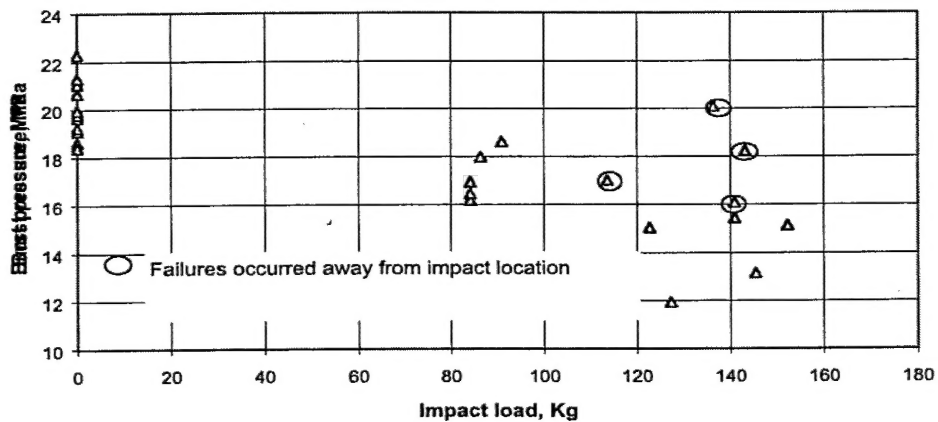
The impact loads typically produced damage consisting of one or two visible line cracks. Photographs of a typical crack are shown in Figure 6. The cracks ran either in the longitudinal or in an off-axis direction. They were typically 1.3 to 1.9-cm (0.5 to 0.75-in.) long depending on the magnitude of the impact. Figure 7 shows the burst pressure as a function of impact load. It shows that the burst pressure decreases significantly with increasing impact force. For impact loads of 823 to 1470 newtons (N) (185 to 330 lb), the burst pressure dropped by as much as 24% to 32%, respectively, compared to the burst pressure of tubes with no impact damage.

Figure 7. Burst pressure versus impact load.

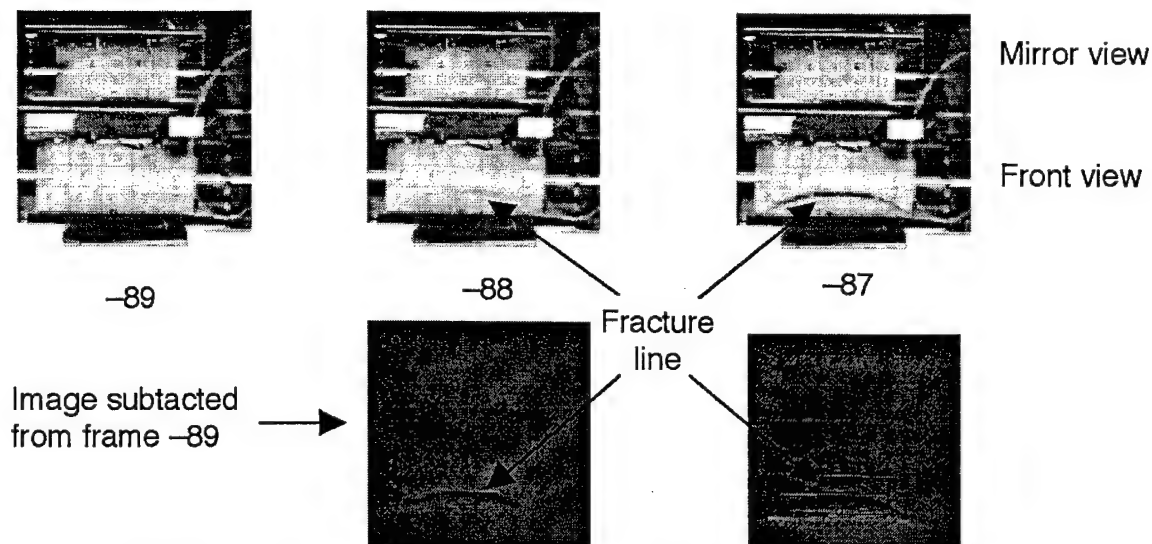
A total of nine specimens were fabricated and tested for this group. The tube specimens were typically 38.1 cm (15 in.) long. The average burst pressure was 19.7 MPa (2860 psi). There are typically two fracture modes for this series. One was a longitudinal mode with a crack running primarily in the axial direction. The second type of failure mode was a slanted crack at about 45° from the axial direction. Figures 8 and 9 depict the two types of failures as well as the subtracted frames from their respective reference frame at 74- μ s time intervals. In Figures 8 and 9, there are two tube images in

Figure 8. Longitudinal failure mode and subtracted images showing the failure sequence of specimen with no fabricated wrinkle (at 13500 frames/s).

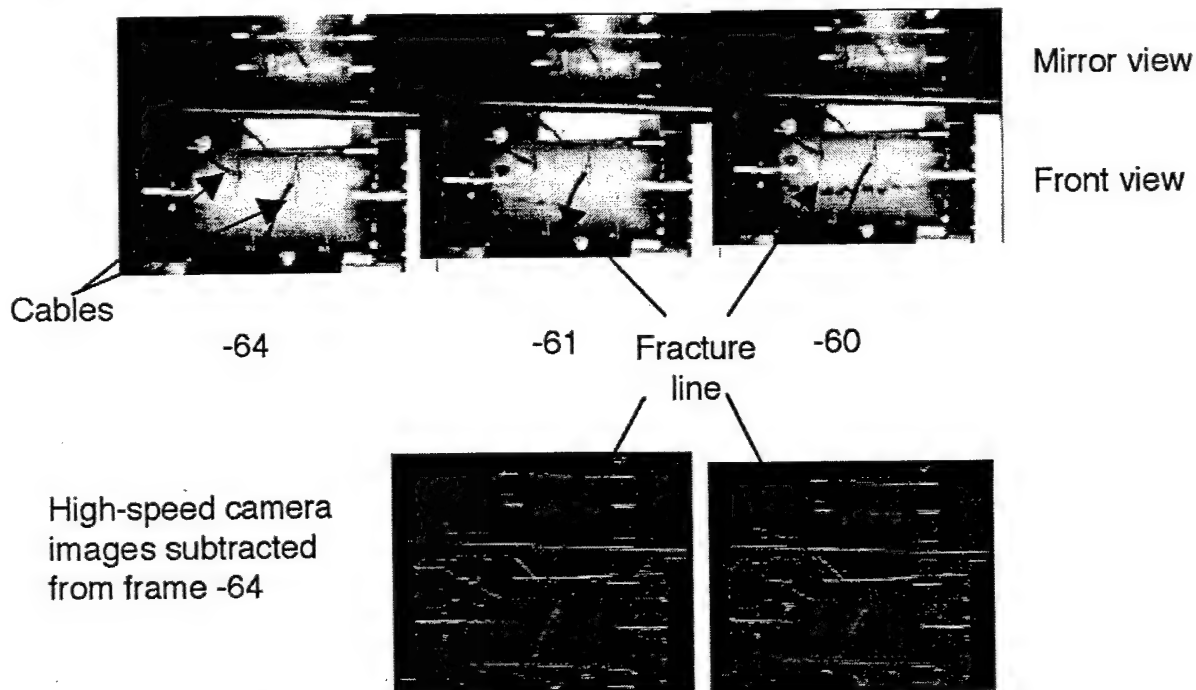
Figure 10. Failure mode and subtracted images showing the failure sequence of specimen with a hoop wrinkle (at 13500 frames/s).

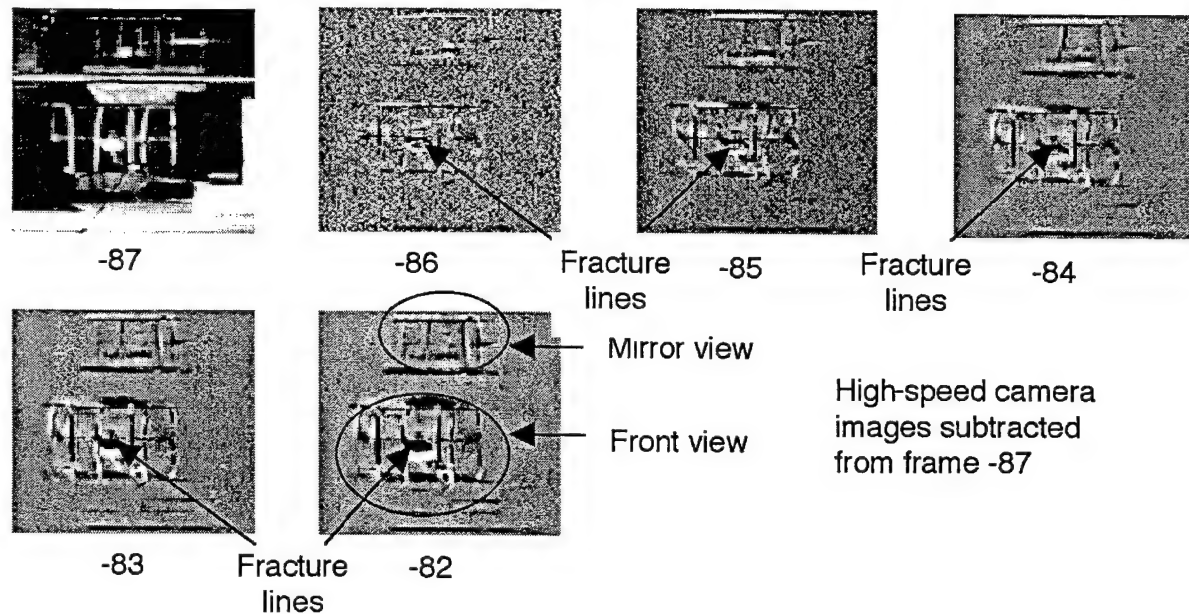
in the helical direction, while the hoop stress was twice the stress in the axial direction. For this series, the number of fibers is more or less balanced in both directions. The stress in the helical fibers became more significant at burst pressure, especially in the wrinkle region. Figures 11 through 13 depict the subtracted images for specimens IV-1, IV-2, and IV-5. Specimen IV-1 had no wrinkle, while specimens IV-2 and IV-5 were wrinkled. From these three figures, it can be seen that the failure for specimen IV-1 was hoop-fiber dominated, the failure of specimen IV-2 was mixed, and the failure of specimen IV-5 was helical-fiber dominated.

Figure 11. Failure mode and subtracted images showing the failure sequence of specimen IV-1 (at 13500 fps).

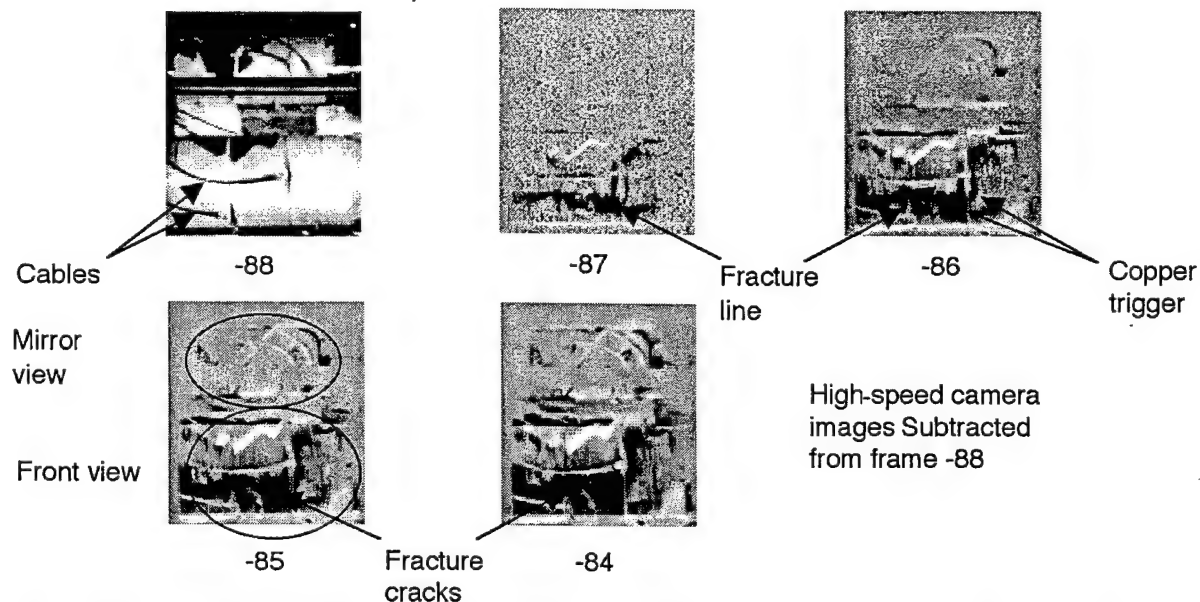
Figure 12. Failure mode and subtracted images showing the failure sequence of specimen IV-2 (at 13500 fps).

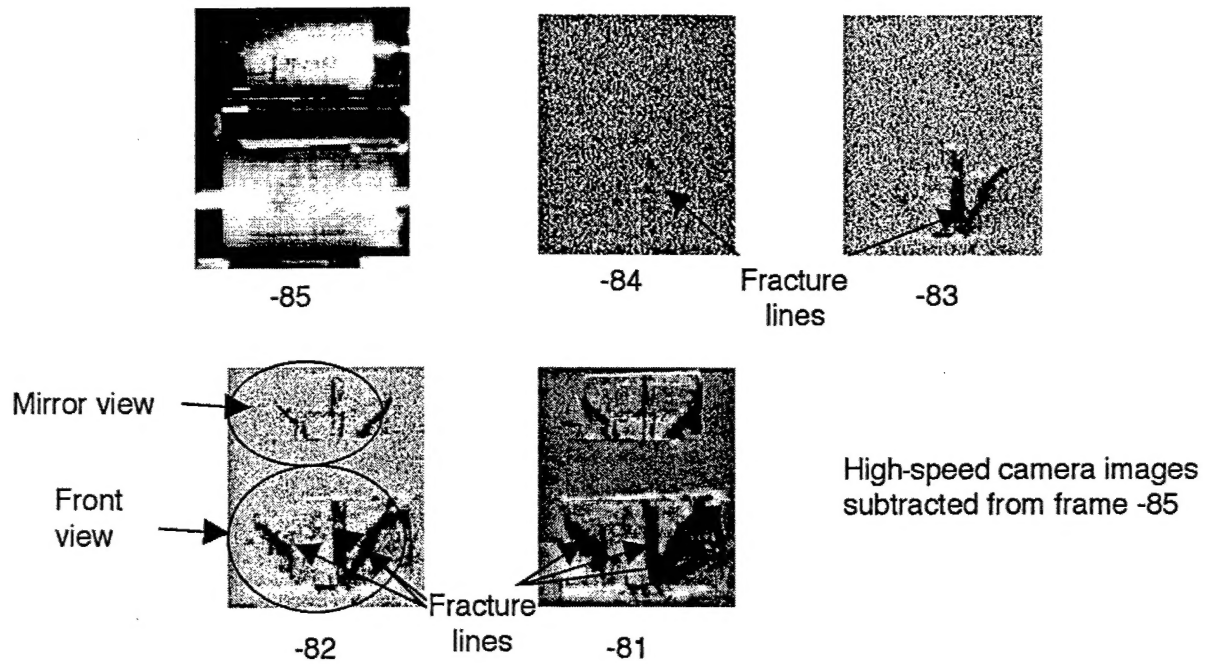
Figure 13. Failure mode and subtracted images showing the failure sequence of specimen IV-5 (at 13500 frames/s).
